Manhole Inspection Summary

Manhole # S41E__070MH

Insp Date: **5/27/09 12:16 PM**

Location Address: **AISQUITH ST**

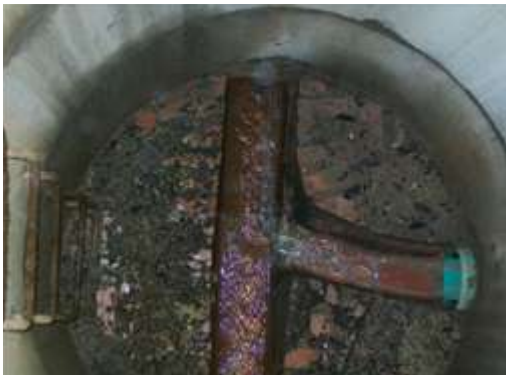
Defect 3

Condition: ☐ Sound ☐ Cracked ☐ Root Intrusion ☐ Deteriorated ☐ Leaks ☒ **Debris**

Count: **7** Missing: **0** ☒ **Corroded**

CORRODED STEPS; BENCH DEBRIS

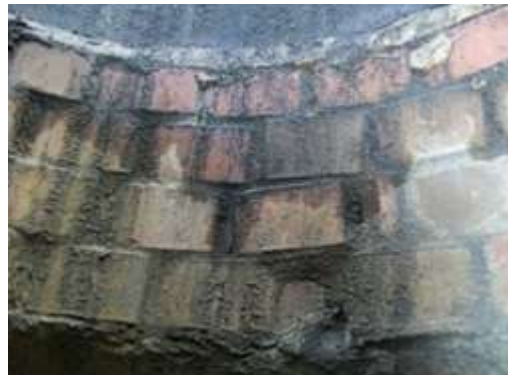
Defect 2

Infiltration: ☐ None ☒ **Joint** ☐ Cracks ☐ Mortar ☐ Roots ☐ Wall

CHIMNEY JOINT INFILTRATION

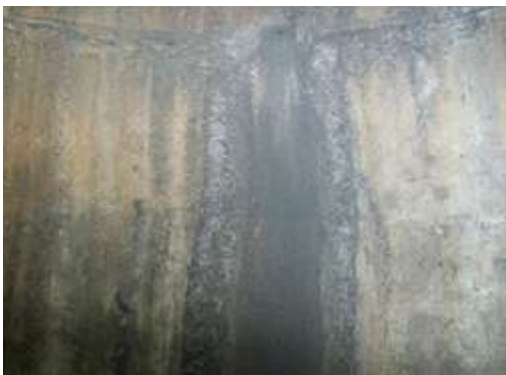
Defect 1

Infiltration: ☐ None ☒ **Joint** ☐ Cracks ☐ Mortar ☐ Roots ☐ Wall

CORBEL JOINT Infiltration

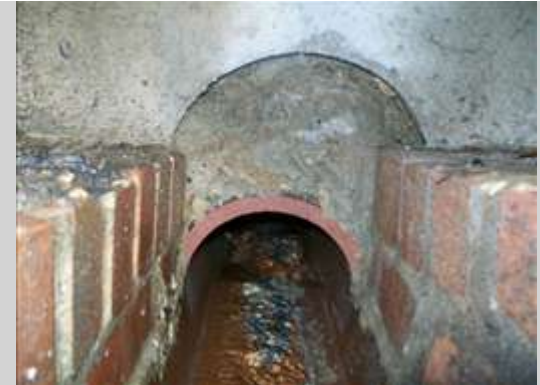
12 O'Clock Outflow

8 in. Circular Gravity Sewer
Pipe Out @ 12 O'Clock

Pipe Height: **8.4** (in.) Rod and Bar (Angled)
Pipe Material: **Clay** ☐ Pipe Lined
Invert Depth: **10.75** (ft.) Flow Characteristics: **Slow**
Deposits: ☐ None ☐ Mud ☐ Sludge ☒ **Debris** ☐ Grease
Silt Depth: **1** (in.) Deposits Extent: **Light**
Infiltration: **None** Pipe Seal Cond: **Broken**

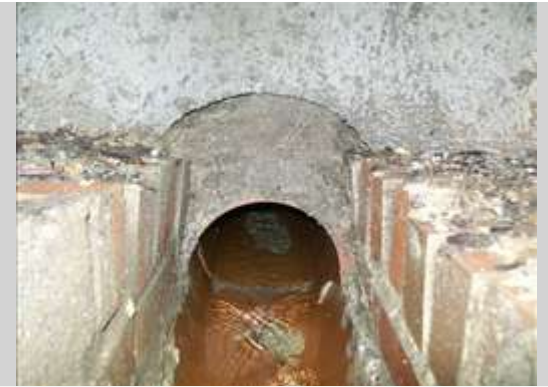
6 O'Clock Inflow

Infiltration: **None** Pipe Seal Cond: **Cracked**
